# m908

## 2.1.x SD Card Flashing Procedure

m908 firmware 2.1.x is a major update for the m908 that enables the web UI for configuration and control of the m908. The nature of the update has changed from previous updates as the entire operating system in the m908 is replaced. If the USB 2.1 migration upgrade process fails the m908 SD card can be flashed with the 2.1 image directly using this procedure.

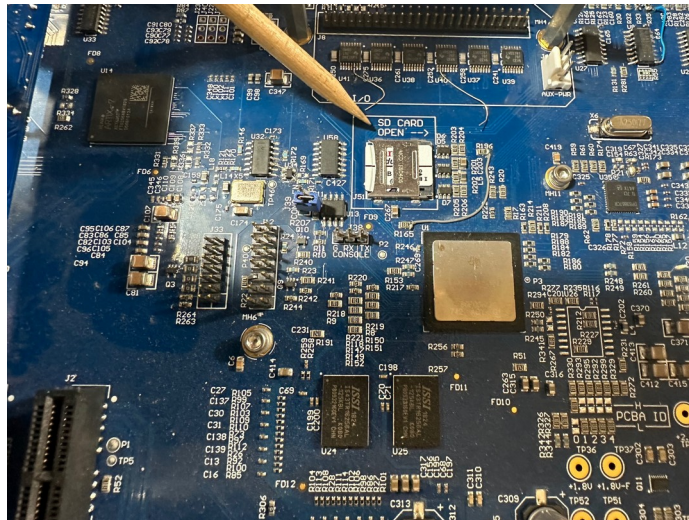
1. Turn off the power to the m908 and disconnect the AC power cable from the DC power supply.
2. With a #2 phillips screwdriver remove the 8 screws securing the ACU top cover.
3. Locate the SD card socket on the main pcba. When looking at the m908 from the front the SD card will be near the middle of the right hand pcb.

*Illustration 1: SD Card Socket Location*

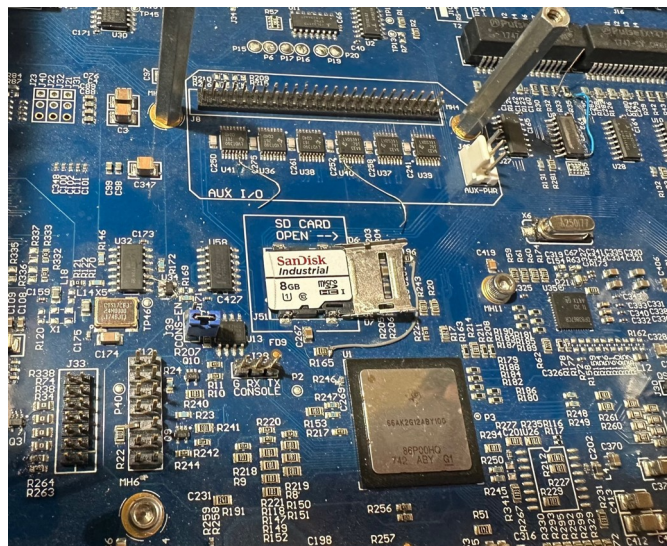
4. Push the metal cover on the SD socket in the direction of the arrow to unlock it. Then flip it over to the right to access the SD card.

*Illustration 2: SD Card Socket Opened*
